TECHNICAL MEMORANDUM TM-2318-SHR

MOISTURE CURED URETHANE (MCU) COATINGS FOR USE ON ANTENNA TOWERS: A FEASIBILITY STUDY

July 1999

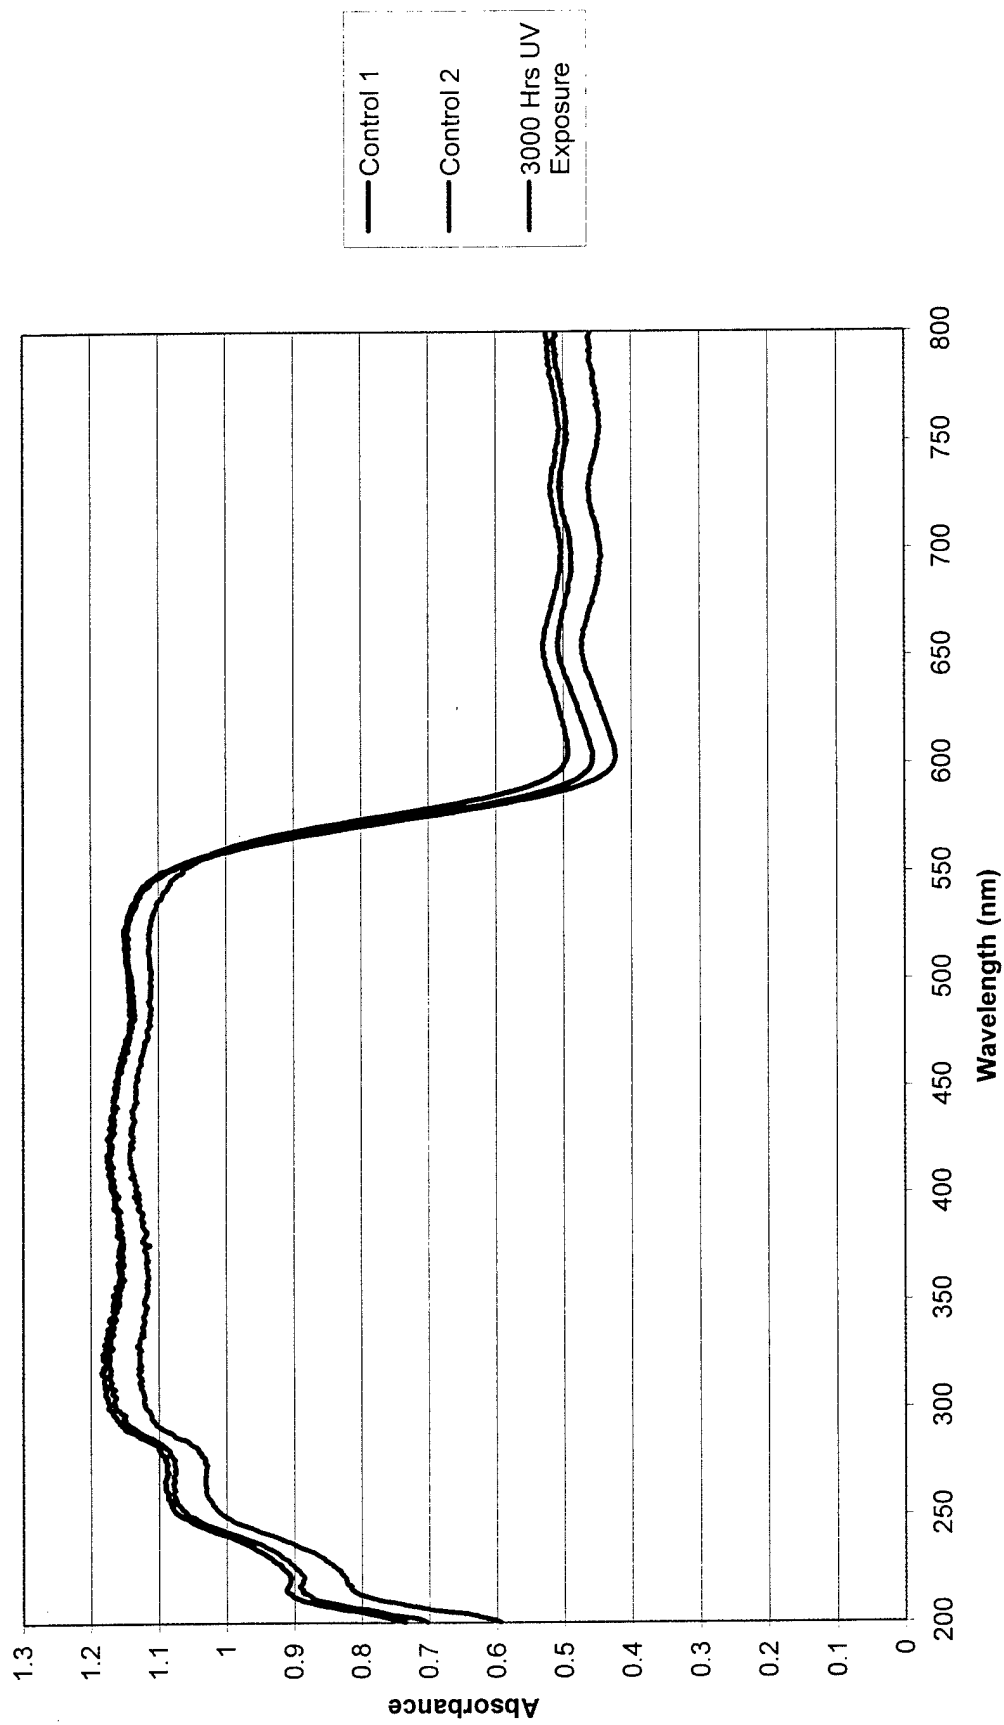
Red-Orange Topcoat E

Controls and 3000 Hours UV Exposure

A Perkin Elmer™ UV/VIS Spectrophotometer was used to evaluate color changes in coating systems subjected to 3,000 hours of Schedule #2 QUV exposure. For each topcoat, three two-inch square samples, cut from the 6" x 12" test panels, were used for the UV/VIS evaluation. Two samples per topcoat color were used to establish baseline visible and UV spectral parameters whereas the third was placed in the QUV and evaluated after 3,000 hours of Schedule #2 exposure. Appendix C contains two spectral printouts per coating system (white topcoat, red-orange topcoat) and shows the two baseline standards superimposed upon the UV exposed sample (absorbance in the visible range (VIS) is at a wavelength from 400 – 700 nanometers (nm), whereas absorbance in the ultra-violet range (UV) is from 200 – 400 nm). The UV-VIS instrument measures the amount of ultraviolet and visible energy absorbed by a coating and, in addition, may be used to correlate chemical changes within the coating. Although several coatings exhibited decreases in both gloss and color retention after QUV exposure, the UV-VIS spectral printouts did not conclusively show either significant increases or decreases in absorbance whereby spectral trends could be identified. Either further UV-VIS spectral analysis or other color analysis is required to quantitatively determine the subtle trends within each spectral printout.

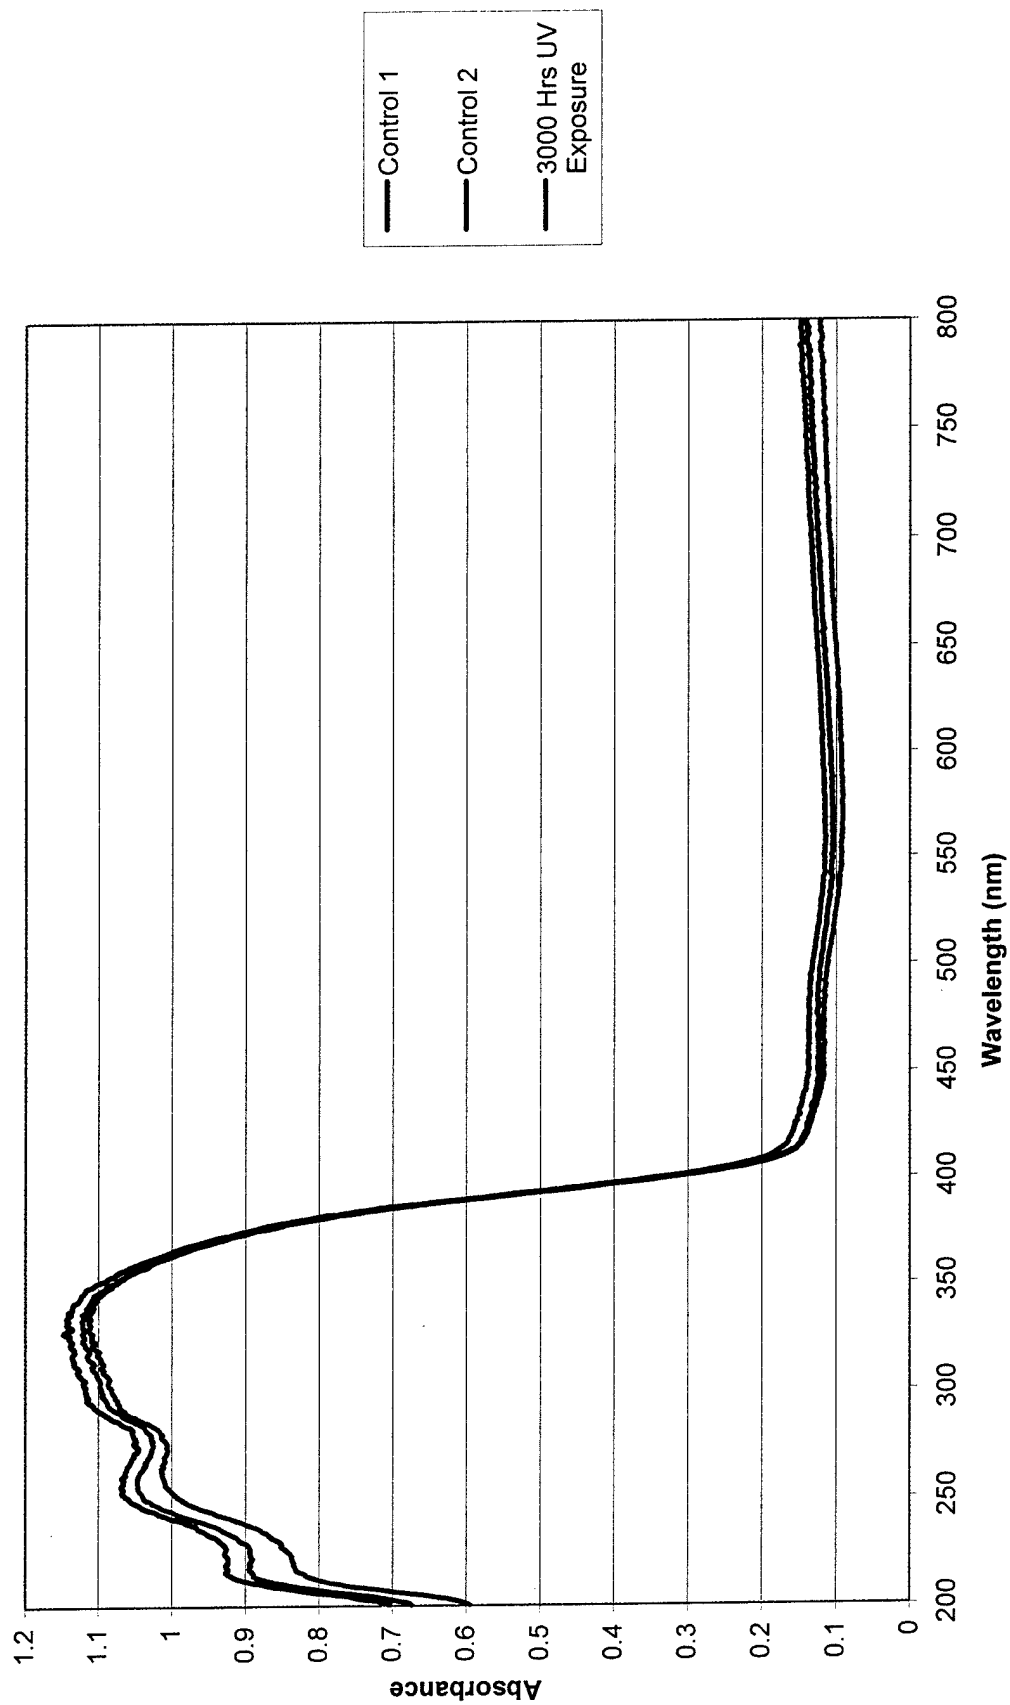
White Topcoat F Controls and 3000 Hours UV Exposure

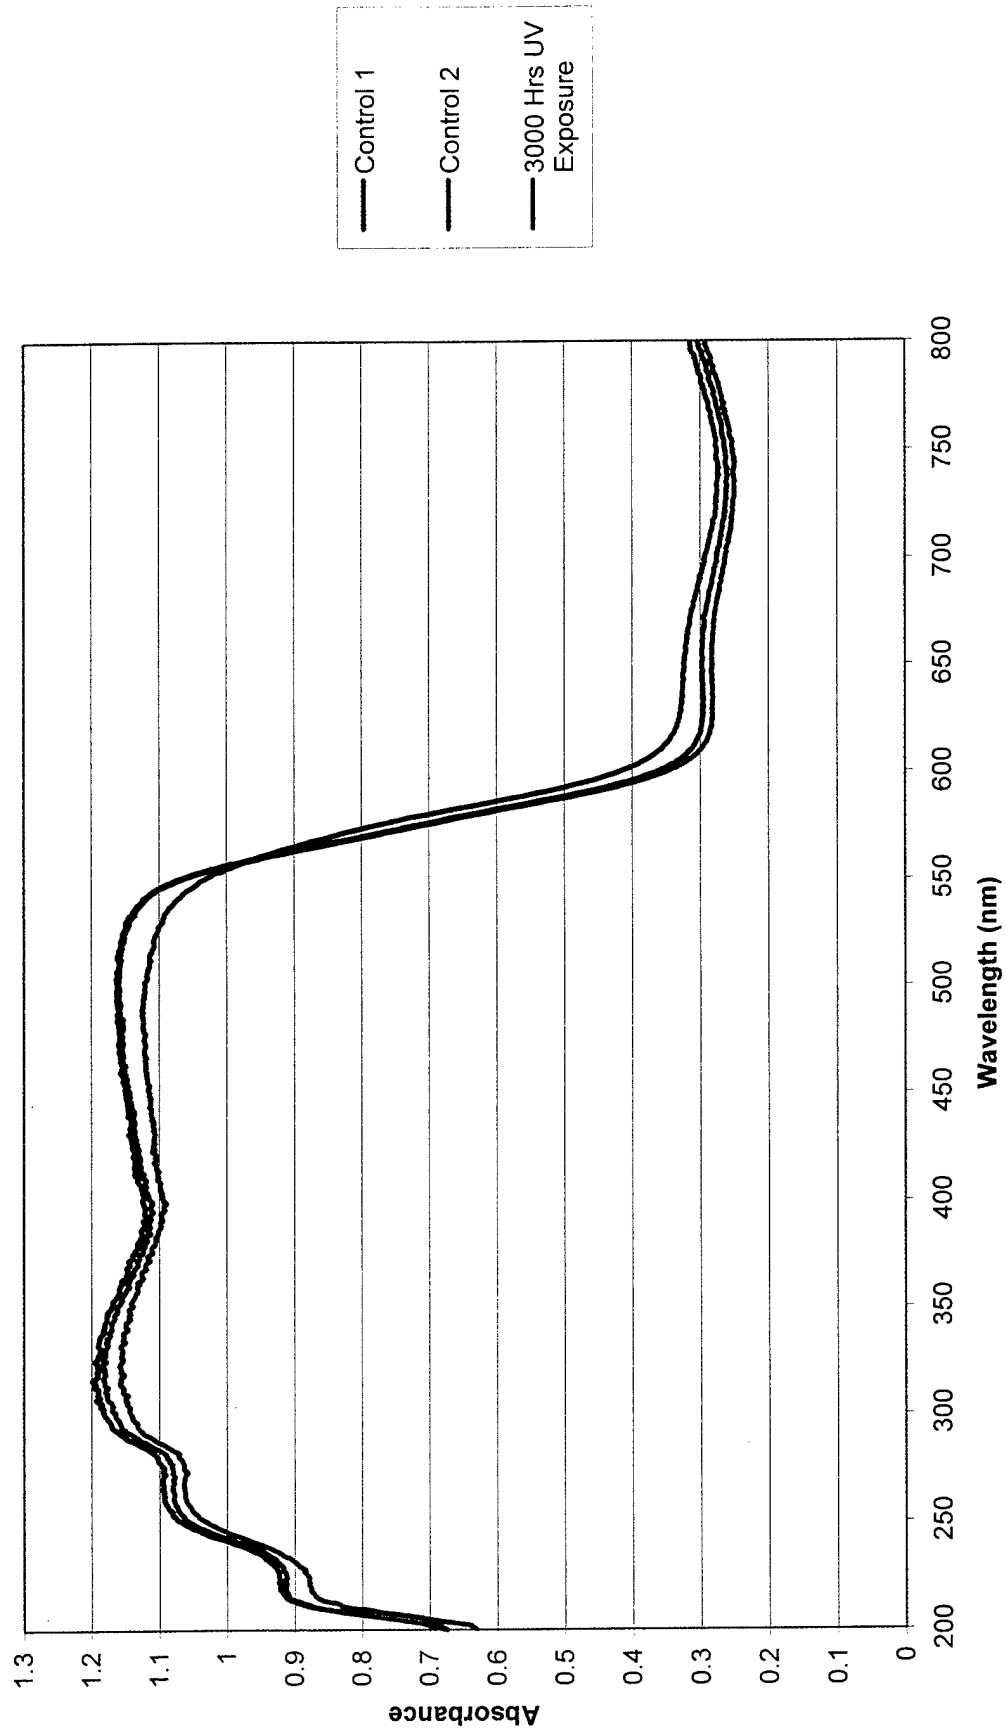
Red-Orange Topcoat F Controls and 3000 Hours UV Exposure

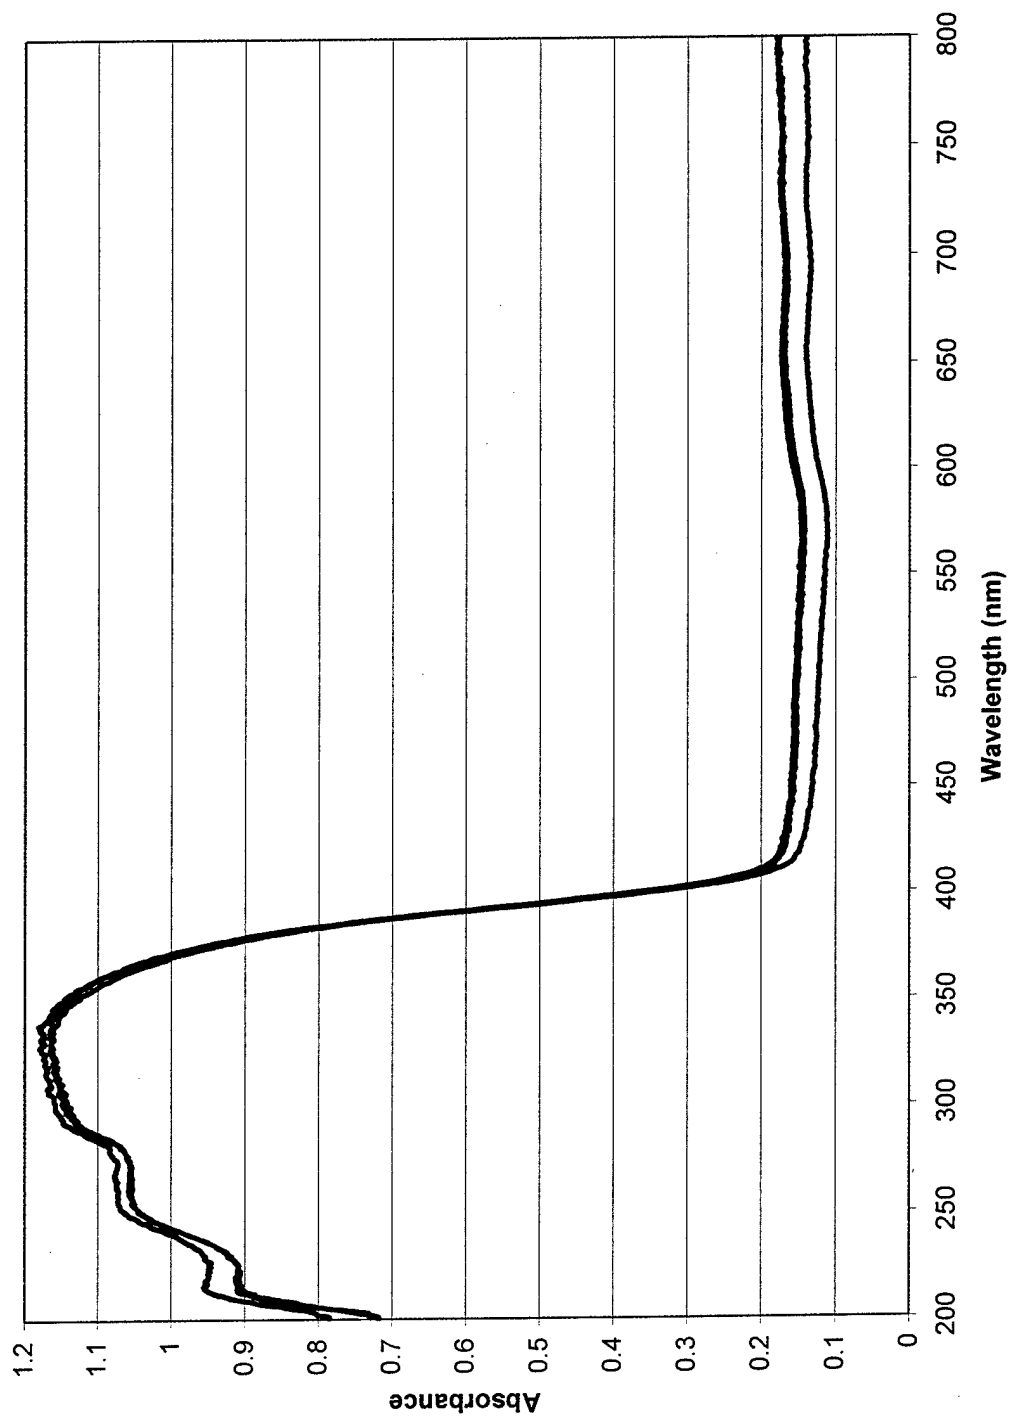
White Topcoat G Controls and 3000 Hours UV Exposure

Control 1
Control 2
3000 Hrs UV Exposure

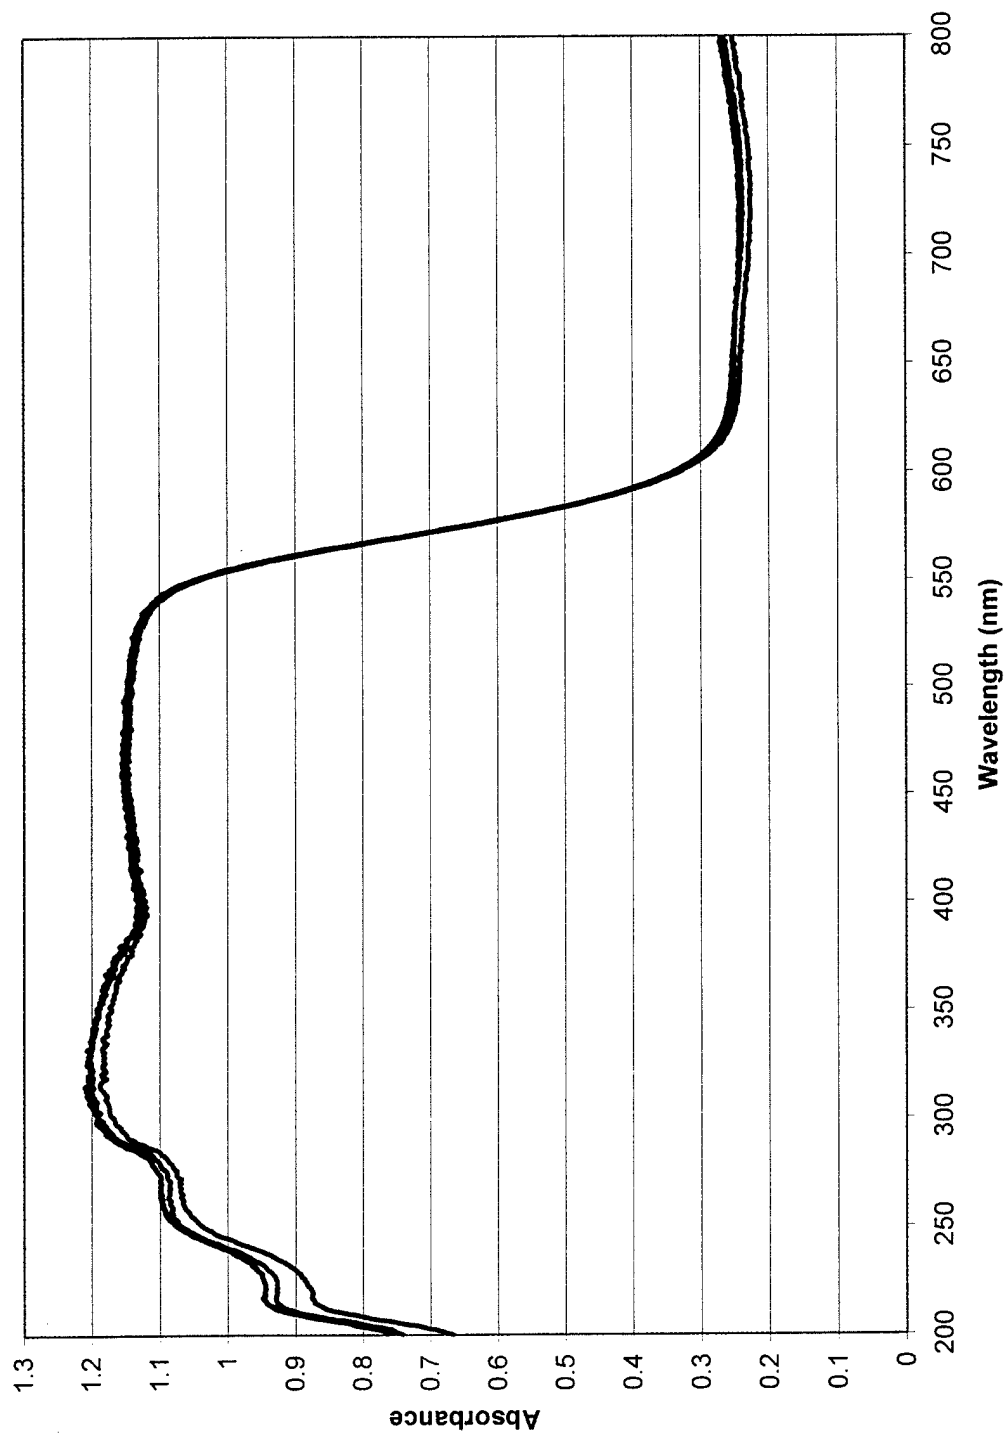
Red-Orange Topcoat G Controls and 3000 Hours UV Exposure

Control 1
Control 2
3000 Hrs UV Exposure

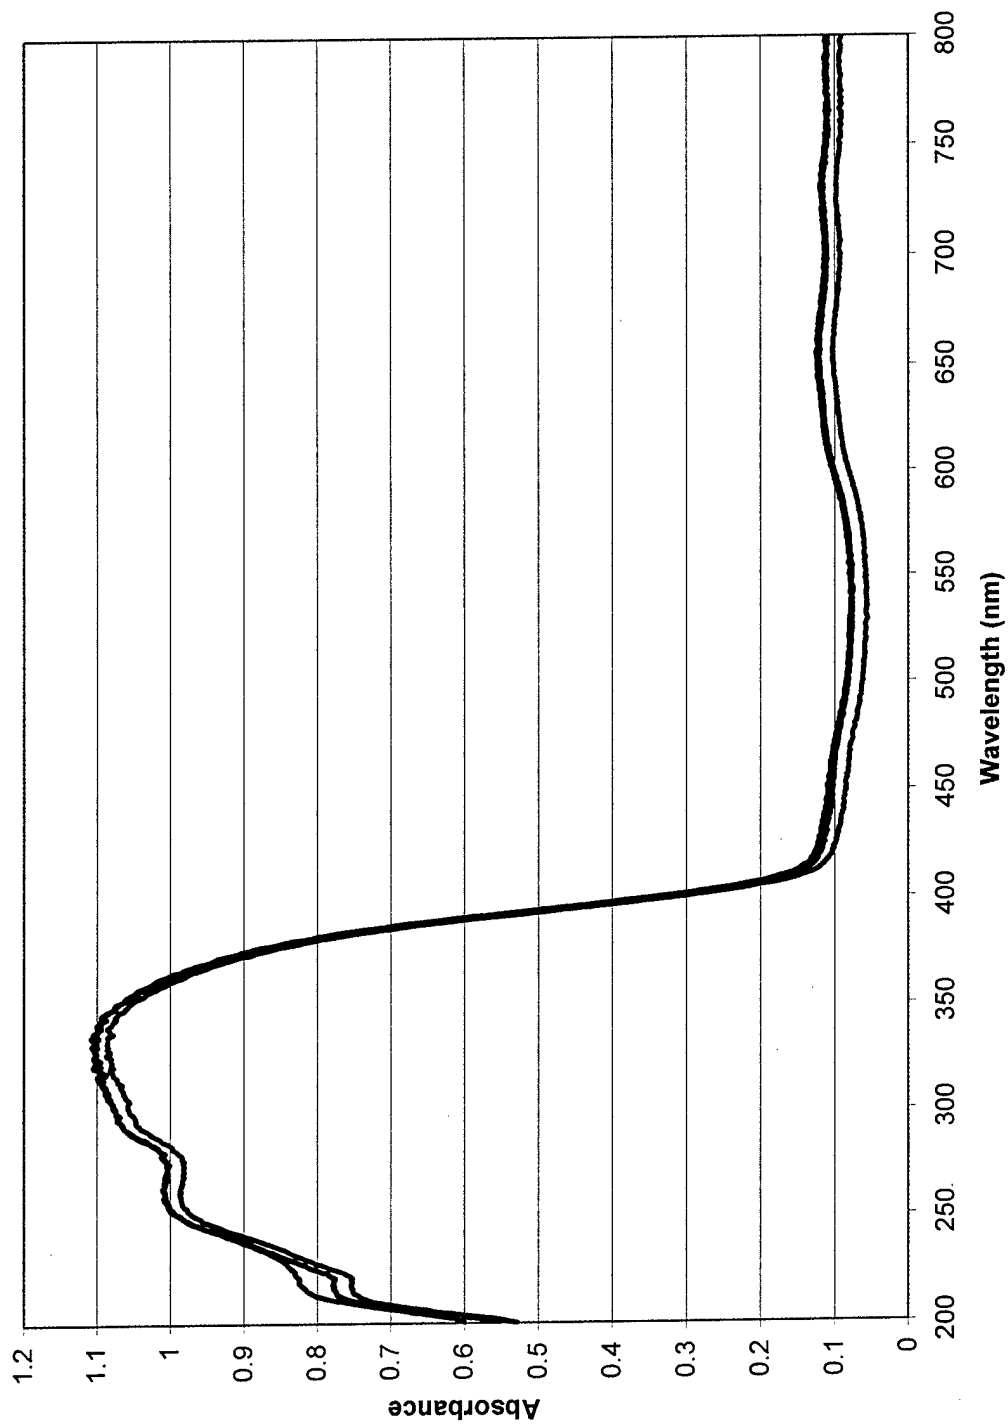
White Topcoat H Controls and 3000 Hours UV Exposure

— Control 1
- - Control 2
... 3000 Hrs UV Exposure

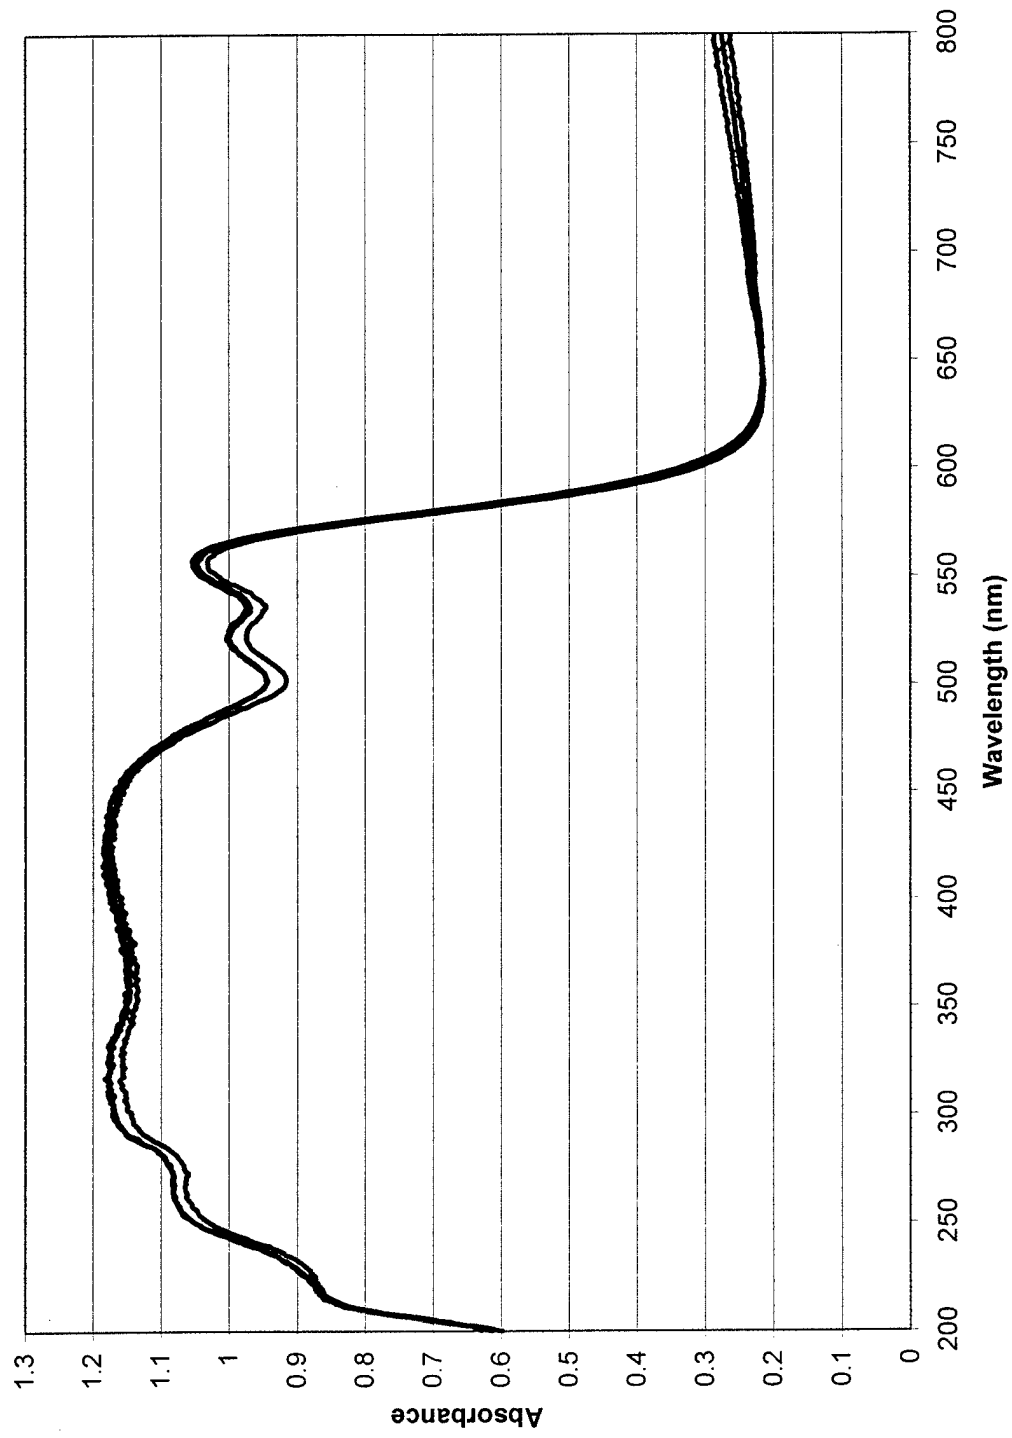
Red-Orange Topcoat H

Controls and 3000 Hours UV Exposure

Control 1
Control 2
3000 Hrs UV Exposure
